**Flood Control Project Maintenance
Levee Inspections**

Fall 2018 Levee Maintenance Deficiency Summary Report

San Joaquin River Basin

Reclamation District No. 0017 Mossdale

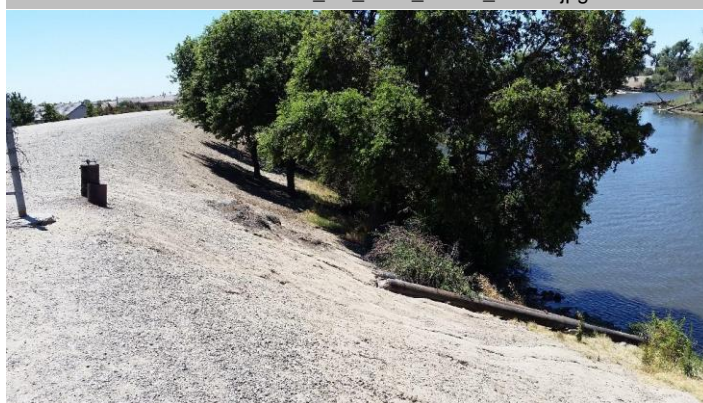
Photo 1 of 3 : UCIP_FA_2018_53331_75741.jpg

UCIP Comments: 9/5/2018 Same as last inspection; WS pipe section completely corroded at section end. Crossing remains Urgent (D. Sanoski - DWR UCIP). 7/12/2016 Same as last inspection--WS pipe section deteriorated. Per Rick Toy, KSN-District Engineer, this crossing is currently owned by the City of Lathrop. Need to coordinate with the City of Lathrop to submit name change to the CVFPB and for the City to provide future use for this crossing. Recommend internal integrity inspection of section of the pipe through the levee. (DWR UCIP - omagana) 5/21/2015 Pipe is still in same condition. Need to contact KSN, LMA engineering firm, to determine update on crossing. (DWR UCIP - omagana) 2/04/2010 Pipe wall has corroded through--wall missing from pipe section located on waterward side. Recommend investigating the pipe integrity through levee section. Damage to pipe has eroded the levee slope on waterward side. Recommend LMA superintendent contact owner to stop using crossing and coordinate with CVFPB to address pipe leak. Owner will need to coordinate with DWR inspector and CVFPB. (DWR UCIP - omagana)

View of WS.

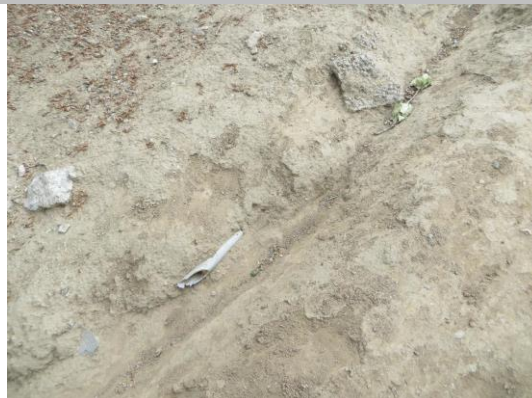
Photo 1 of 2 : UCIP_FA_2018_45453_74112.jpg

Comment Code					
Inspector Comment					
FS_ID:45453 DS_ID:48 EP_NO: 15084 Repair Type: Non-Urgent Crossing Status: Indicator Found UCIP Comments: Need to contact owner to determine disposition of pipe. No record of removal has been found and status of crossing needs to be determined. FIELD_STRUCT_DESC: 8-inch steel irrigation pipe through levee, 2.80 feet below levee crown. (Siphon breaker on landside (LS) shoulder. Slant pump on waterside (WS) slope, concrete stairway from pump to WS shoulder, standpipe located 20 feet from the LS toe): Not found. Only indicator is a 1.5-inch PVC electrical conduit visible on WS slope 6-feet below the crown. (8-inch pipe authorized under Permit No. 15084, 1989 - F. G. and B. J. Terry, existing 8-inch pipe removed) [Additional Reference(s): DWR Levee Logs, 1981 and 2003] FS Date: 5/21/2015

Electrical conduit only appurtanance found on WS slope.

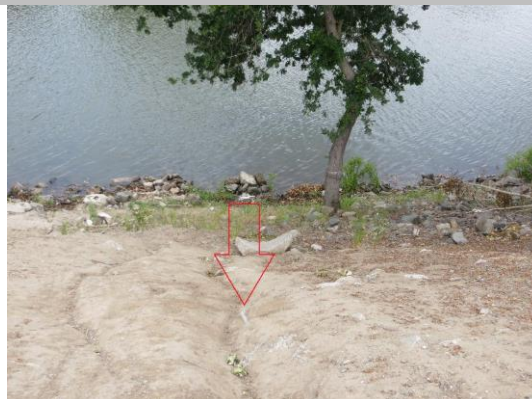
Photo 2 of 2 : UCIP_FA_2018_45453_74113.jpg

1.5-inch electrical conduit only appurtanance still visible on WS slope.

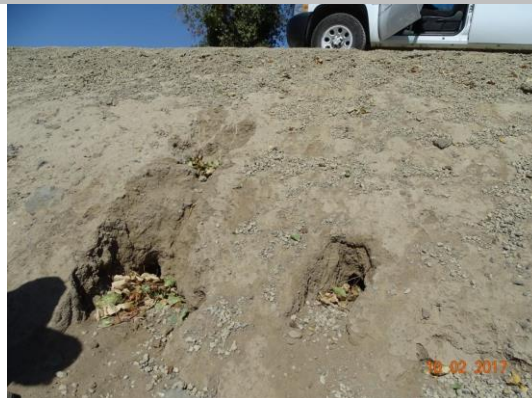
Photo 1 of 1 : FA_2018_RD0017_304_85_20180906_00015.jpg

LM Start	9.24	Rating **	M	Issue No.	85
LM End	9.24	Issue Type +	Ma	Location *	LS
Category	Earthen Levee			GPS Latitude/Longitude	
				Start	End
Item	Animal Control			37.815269 °	37.815269 °
				-121.316805 °	-121.316805 °
DWR ID	DWR_RD0017_02_f_2017_85				
Comment Code					
A3 : No rodents visible, but rodent burrows visible; need to backfill and compact or grout burrows.					
Inspector Comment

Looking north at landside slope.

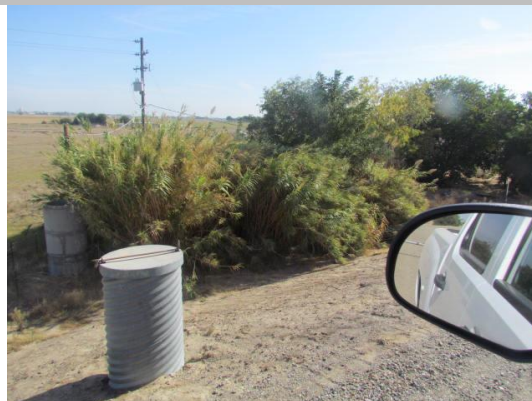
Photo 1 of 1 : FA_2018_RD0017_304_9_20180906_00010.jpg

LM Start	9.29	Rating **	M	Issue No.	9
LM End	9.29	Issue Type +	Ma	Location *	LS
Category	Earthen Levee			GPS Latitude/Longitude	
				Start	End
Item	Vegetation			37.815270 °	37.815270 °
				-121.317692 °	-121.317692 °
DWR ID	DWR_RD0017_02_s_2012_9				
Comment Code					
V4 : Elderberries are blocking visibility and flood fight capability.					
Inspector Comment					
Bamboo & elderberries at landside toe.

Looking east at bamboo and elderberries at landward toe.

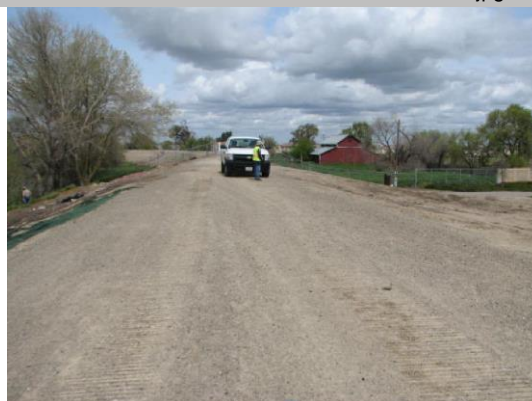
Photo 1 of 3 : UCIP_FA_2018_40695_72420.jpg

Comment Code						
Inspector Comment						
FS_ID:40695 DS_ID:51 EP_NO: 15055 Repair Type: Non-Urgent Crossing Status: Found UCIP Comments: Pipe is not connected on waterward side. Crossing is non-functional recommend contacting owner to determine status of crossing. If crossing is no longer used need to coordinate with CVFPB for proper abandonment. FIELD_STRUCT_DESC: 16-inch steel irrigation pipe through levee, 2.77 feet below levee crown. Siphon breaker on landside (LS) shoulder. Slant pump on waterside (WS) slope, standpipe located 11 feet from the LS toe. (16-inch pipe authorized under Permit No. 15055, 1989 - F. G. and B. J. Terry, existing 14-inch pipe removed) [Additional Reference(s): DWR Levee Logs, 1981 and 2003] FS Date: 2/4/2010

Overview of levee crown at crossing.

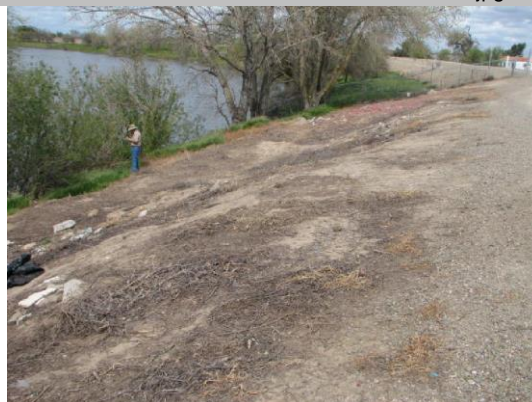
Photo 2 of 3 : UCIP_FA_2018_40695_72418.jpg

View of waterward side.

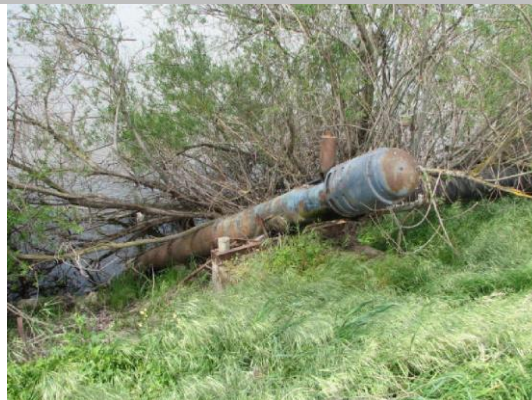
Photo 3 of 3 : UCIP_FA_2018_40695_72421.jpg

Item	DWR UCIP Field Study			37.803410 °	37.803410 °	
				-121.312031 °	-121.312031 °	
DWR ID	51					
Comment Code						
Inspector Comment						
FS_ID:40695 DS_ID:51 EP_NO: 15055 Repair Type: Non-Urgent Crossing Status: Found UCIP Comments: Pipe is not connected on waterward side. Crossing is non-functional recommend contacting owner to determine status of crossing. If crossing is no longer used need to coordinate with CVFPB for proper abandonment. FIELD_STRUCT_DESC: 16-inch steel irrigation pipe through levee, 2.77 feet below levee crown. Siphon breaker on landside (LS) shoulder. Slant pump on waterside (WS) slope, standpipe located 11 feet from the LS toe. (16-inch pipe authorized under Permit No. 15055, 1989 - F. G. and B. J. Terry, existing 14-inch pipe removed) [Additional Reference(s): DWR Levee Logs, 1981 and 2003] FS Date: 2/4/2010

Slant pump located on waterward side.

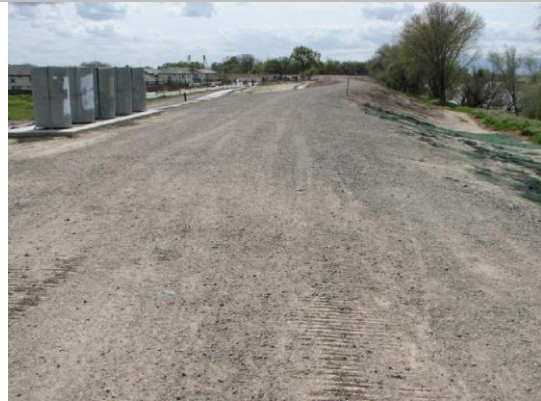
Photo 1 of 3 : UCIP_FA_2018_40696_72440.jpg

Comment Code						
Inspector Comment						
FS_ID:40696 DS_ID:103 EP_NO: 17792 Repair Type: Non-Urgent Crossing Status: Found UCIP Comments: Surface erosion on waterward slope--Need to contact owner. FIELD_STRUCT_DESC: [Mossdale Outfall] 1 of 6. 30-inch steel drainage pipe through levee at unknown depth. Structure is part of Lathrop City Stormwater Pump Station 112. Station consists 6 drainage pipes, pump station, air release valves, and concrete headwall. Air release valves located inside risers are located on landside (LS) shoulder on top of concrete pad. Concrete headwall and gates located on waterside (WS). (six 30-inch pipes authorized under Permit No. 17792, 2005 - City of Lathrop) FS Date: 2/4/2010

Overview of levee crown at crossing.

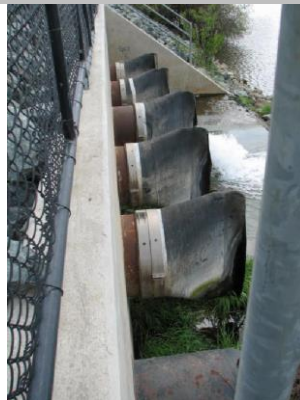
Photo 3 of 3 : UCIP_FA_2018_40696_72449.jpg

Item	DWR UCIP Field Study			37.802921 °	37.802921 °	
				-121.311947 °	-121.311947 °	
DWR ID	103					
Comment Code						
Inspector Comment						
FS_ID:40696 DS_ID:103 EP_NO: 17792 Repair Type: Non-Urgent Crossing Status: Found UCIP Comments: Surface erosion on waterward slope--Need to contact owner. FIELD_STRUCT_DESC: [Mossdale Outfall] 1 of 6. 30-inch steel drainage pipe through levee at unknown depth. Structure is part of Lathrop City Stormwater Pump Station 112. Station consists 6 drainage pipes, pump station, air release valves, and concrete headwall. Air release valves located inside risers are located on landside (LS) shoulder on top of concrete pad. Concrete headwall and gates located on waterside (WS). (six 30-inch pipes authorized under Permit No. 17792, 2005 - City of Lathrop) FS Date: 2/4/2010

Concrete headwall and gates located on waterward toe.

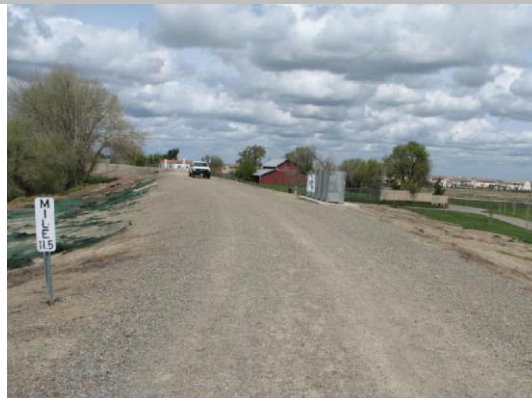
Photo 1 of 3 : UCIP_FA_2018_40697_72452.jpg

Comment Code						
Inspector Comment						
FS_ID:40697						
DS_ID:473						
EP_NO: 17792						
Repair Type: Non-Urgent						
Crossing Status: Found						
UCIP Comments: Surface erosion on waterward slope--need to contact owner.						
FIELD_STRUCT_DESC: [Mossdale Outfall] 2 of 6. 30-inch steel drainage pipe through levee at unknown depth. Structure is part of Lathrop City Stormwater Pump Station 112. Station consists 6 drainage pipes, pump station, air release valves, and concrete headwall. Air release valves located inside risers are located on landside (LS) shoulder on top of concrete pad. Concrete headwall and gates located on waterside (WS). (six 30-inch pipes authorized under Permit No. 17792, 2005 - City of Lathrop)						
FS Date: 2/4/2010

Overview of levee crown at crossings.

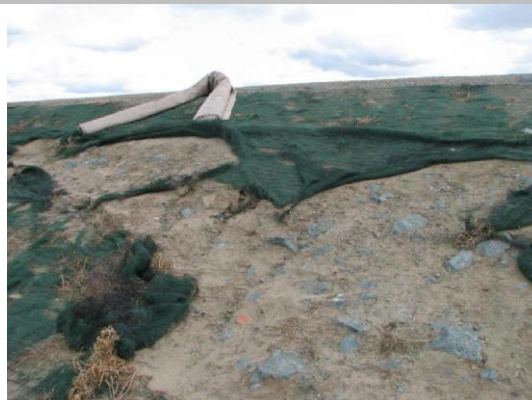
Photo 2 of 3 : UCIP_FA_2018_40697_72453.jpg

Geotech fabric damage along waterward berm.

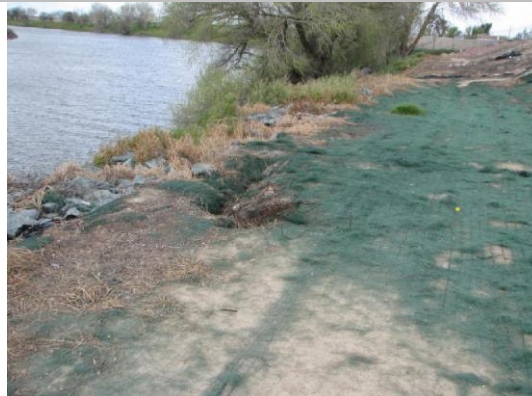
Photo 3 of 3 : UCIP_FA_2018_40697_72450.jpg

Item	DWR UCIP Field Study			37.802904 °	37.802904 °	
				-121.311946 °	-121.311946 °	
DWR ID	473					
Comment Code						
Inspector Comment						
FS_ID:40697 DS_ID:473 EP_NO: 17792 Repair Type: Non-Urgent Crossing Status: Found UCIP Comments: Surface erosion on waterward slope--need to contact owner. FIELD_STRUCT_DESC: [Mossdale Outfall] 2 of 6. 30-inch steel drainage pipe through levee at unknown depth. Structure is part of Lathrop City Stormwater Pump Station 112. Station consists 6 drainage pipes, pump station, air release valves, and concrete headwall. Air release valves located inside risers are located on landside (LS) shoulder on top of concrete pad. Concrete headwall and gates located on waterside (WS). (six 30-inch pipes authorized under Permit No. 17792, 2005 - City of Lathrop) FS Date: 2/4/2010

Surface erosion visible on waterward berm edge.

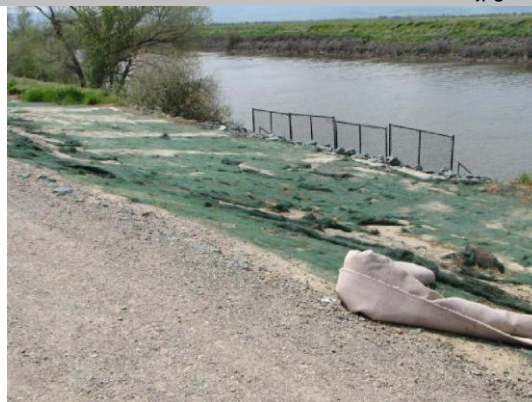
Photo 2 of 3 : UCIP_FA_2018_40698_72477.jpg

Comment Code					
Inspector Comment					
FS_ID:40698 DS_ID:474 EP_NO: 17792 Repair Type: Non-Urgent Crossing Status: Found UCIP Comments: Surface erosion on waterward slope--need to contact owner. FIELD_STRUCT_DESC: [Mossdale Outfall] 3 of 6. 30-inch steel drainage pipe through levee at unknown depth. Structure is part of Lathrop City Stormwater Pump Station 112. Station consists 6 drainage pipes, pump station, air release valves, and concrete headwall. Air release valves located inside risers are located on landside (LS) shoulder on top of concrete pad. Concrete headwall and gates located on waterside (WS). (six 30-inch pipes authorized under Permit No. 17792, 2005 - City of Lathrop) FS Date: 2/4/2010

View of waterward side.

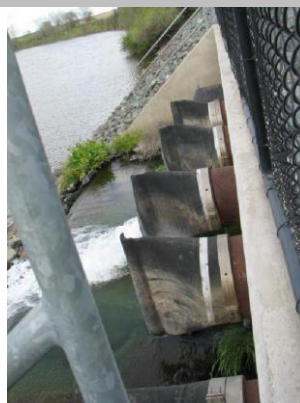
Photo 3 of 3 : UCIP_FA_2018_40698_72474.jpg

Item	DWR UCIP Field Study			37.802889 °	37.802889 °	
				-121.311947 °	-121.311947 °	
DWR ID	474					
Comment Code						
Inspector Comment						
FS_ID:40698 DS_ID:474 EP_NO: 17792 Repair Type: Non-Urgent Crossing Status: Found UCIP Comments: Surface erosion on waterward slope--need to contact owner. FIELD_STRUCT_DESC: [Mossdale Outfall] 3 of 6. 30-inch steel drainage pipe through levee at unknown depth. Structure is part of Lathrop City Stormwater Pump Station 112. Station consists 6 drainage pipes, pump station, air release valves, and concrete headwall. Air release valves located inside risers are located on landside (LS) shoulder on top of concrete pad. Concrete headwall and gates located on waterside (WS). (six 30-inch pipes authorized under Permit No. 17792, 2005 - City of Lathrop) FS Date: 2/4/2010

Outlet structure located on waterward toe.

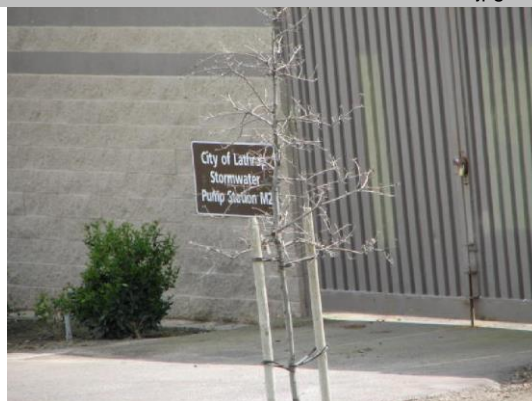
Photo 1 of 3 : UCIP_FA_2018_40699_72458.jpg

Comment Code						
Inspector Comment						
FS_ID:40699 DS_ID:475 EP_NO: 17792 Repair Type: Non-Urgent Crossing Status: Found UCIP Comments: Surface erosion on waterward slope--need to contact owner. FIELD_STRUCT_DESC: [Mossdale Outfall] 4 of 6. 30-inch steel drainage pipe through levee at unknown depth. Structure is part of Lathrop City Stormwater Pump Station 112. Station consists 6 drainage pipes, pump station, air release valves, and concrete headwall. Air release valves located inside risers are located on landside (LS) shoulder on top of concrete pad. Concrete headwall and gates located on waterside (WS). (six 30-inch pipes authorized under Permit No. 17792, 2005 - City of Lathrop) FS Date: 2/4/2010

City of Lathrop Stormwater Pump Station 112.

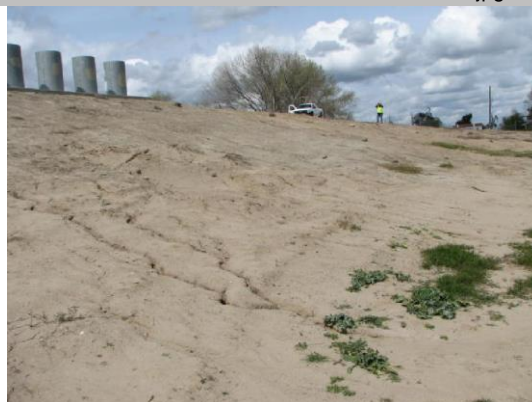
Photo 2 of 3 : UCIP_FA_2018_40699_72457.jpg

View of landward side.

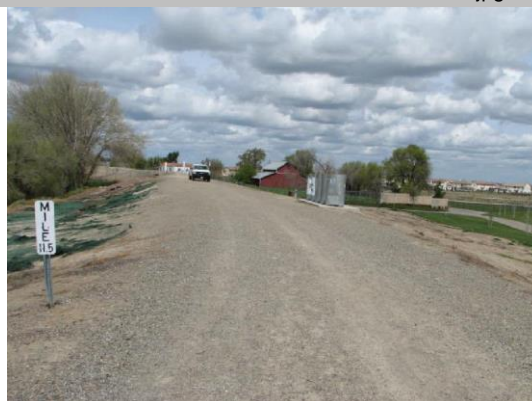
Photo 3 of 3 : UCIP_FA_2018_40699_72456.jpg

Item	DWR UCIP Field Study			37.802869 °	37.802869 °	
				-121.311948 °	-121.311948 °	
DWR ID	475					
Comment Code						
Inspector Comment						
FS_ID:40699 DS_ID:475 EP_NO: 17792 Repair Type: Non-Urgent Crossing Status: Found UCIP Comments: Surface erosion on waterward slope--need to contact owner. FIELD_STRUCT_DESC: [Mossdale Outfall] 4 of 6. 30-inch steel drainage pipe through levee at unknown depth. Structure is part of Lathrop City Stormwater Pump Station 112. Station consists 6 drainage pipes, pump station, air release valves, and concrete headwall. Air release valves located inside risers are located on landside (LS) shoulder on top of concrete pad. Concrete headwall and gates located on waterside (WS). (six 30-inch pipes authorized under Permit No. 17792, 2005 - City of Lathrop) FS Date: 2/4/2010

Overview of levee crown at crossings.

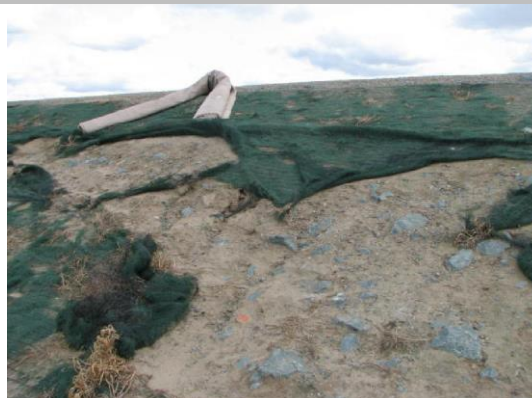
Photo 3 of 3 : UCIP_FA_2018_40700_72465.jpg

Item	DWR UCIP Field Study			37.802854 °	37.802854 °	
				-121.311948 °	-121.311948 °	
DWR ID	476					
Comment Code						
Inspector Comment						
FS_ID:40700 DS_ID:476 EP_NO: 17792 Repair Type: Non-Urgent Crossing Status: Found UCIP Comments: Surface erosion on waterward slope--need to contact owner. FIELD_STRUCT_DESC: [Mossdale Outfall] 5 of 6. 30-inch steel drainage pipe through levee at unknown depth. Structure is part of Lathrop City Stormwater Pump Station 112. Station consists 6 drainage pipes, pump station, air release valves, and concrete headwall. Air release valves located inside risers are located on landside (LS) shoulder on top of concrete pad. Concrete headwall and gates located on waterside (WS). (six 30-inch pipes authorized under Permit No. 17792, 2005 - City of Lathrop) FS Date: 2/4/2010

Surface erosion on waterward side.

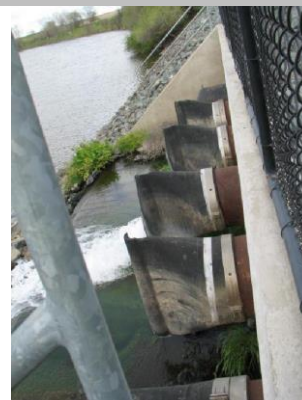
Photo 2 of 3 : UCIP_FA_2018_40701_72469.jpg

Comment Code						
Inspector Comment						
FS_ID:40701						
DS_ID:477						
EP_NO: 17792						
Repair Type: Non-Urgent						
Crossing Status: Found						
UCIP Comments: Surface erosion on waterward slope--need to contact owner.						
FIELD_STRUCT_DESC: [Mossdale Outfall] 6 of 6. 30-inch steel drainage pipe through levee at unknown depth. Structure is part of Lathrop City Stormwater Pump Station 112. Station consists 6 drainage pipes, pump station, air release valves, and concrete headwall. Air release valves located inside risers are located on landside (LS) shoulder on top of concrete pad. Concrete headwall and gates located on waterside (WS). (six 30-inch pipes authorized under Permit No. 17792, 2005 - City of Lathrop)						
FS Date: 2/4/2010

Outlet concrete headwall and gates on waterward toe.

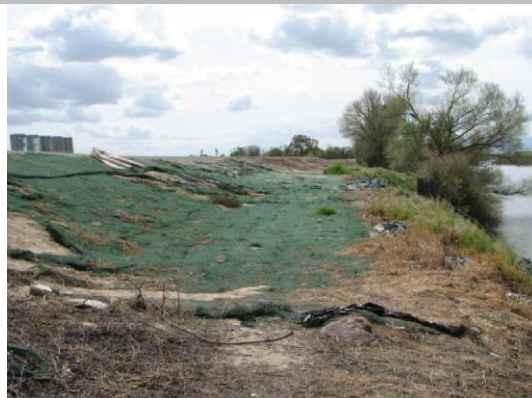
Photo 3 of 3 : UCIP_FA_2018_40701_72468.jpg

Item	DWR UCIP Field Study			37.802837 °	37.802837 °	
				-121.311949 °	-121.311949 °	
DWR ID	477					
Comment Code						
Inspector Comment						
FS_ID:40701 DS_ID:477 EP_NO: 17792 Repair Type: Non-Urgent Crossing Status: Found UCIP Comments: Surface erosion on waterward slope--need to contact owner. FIELD_STRUCT_DESC: [Mossdale Outfall] 6 of 6. 30-inch steel drainage pipe through levee at unknown depth. Structure is part of Lathrop City Stormwater Pump Station 112. Station consists 6 drainage pipes, pump station, air release valves, and concrete headwall. Air release valves located inside risers are located on landside (LS) shoulder on top of concrete pad. Concrete headwall and gates located on waterside (WS). (six 30-inch pipes authorized under Permit No. 17792, 2005 - City of Lathrop) FS Date: 2/4/2010

View of waterward side.

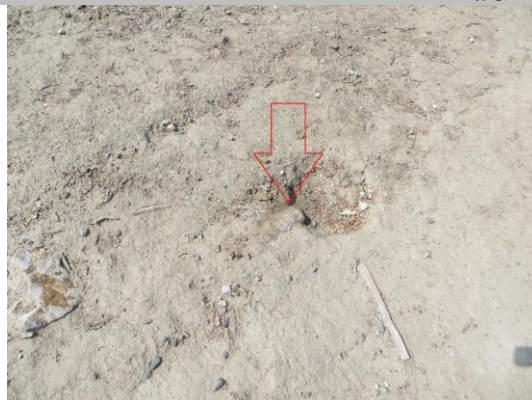
Photo 1 of 3 : UCIP_FA_2018_45463_74122.jpg

LM Start	11.43	Rating **	M	Issue No.	136
LM End	11.43	Issue Type +	En	Location *	
Category	Supplemental			GPS Latitude/Longitude	
				Start	End
Item	DWR UCIP Field Study			37.801683 °	37.801683 °
				-121.312001 °	-121.312001 °
DWR ID	53				
Comment Code					
Inspector Comment					
FS_ID:45463 DS_ID:53 EP_NO: 15125 Repair Type: Non-Urgent Crossing Status: Indicator Found UCIP Comments: Pipe appears abandoned as vent is partially buried and pipe not visible. If abandoned, it should be done so properly. FIELD_STRUCT_DESC: 7-inch steel pipe through the levee 3.59-feet below levee crown. Siphon breaker located on landside (LS) shoulder. Air vent found on waterside (WS) slope (7-inch installed under Permit No. 15125, 1989 - T. Osborn, Jr., existing 8-inch PVC pipe removed). [Additional Reference(s): DWR Levee Logs, 1981 and 2003] FS Date: 5/21/2015

Vent visible on WS slope. Found partially buried.

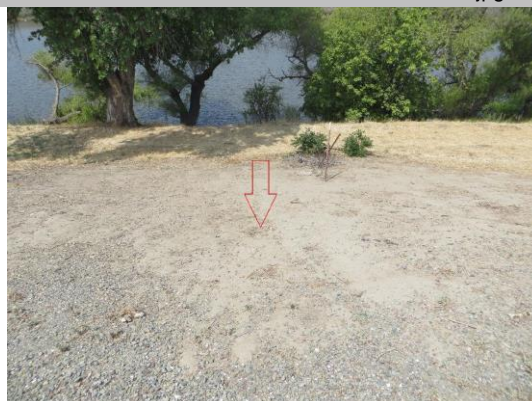
Photo 2 of 3 : UCIP_FA_2018_45463_74121.jpg

Vent visible on WS slope. Found partially burried.

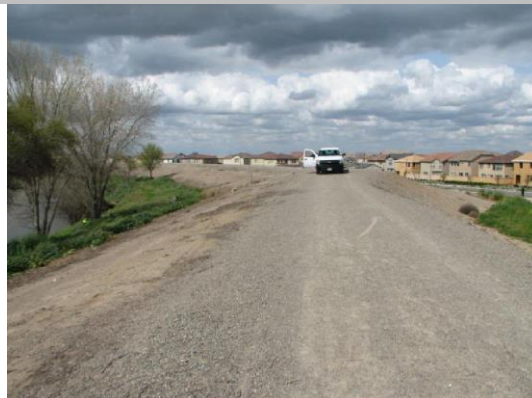
Photo 1 of 3 : UCIP_FA_2018_40702_72481.jpg

Comment Code					
Inspector Comment					
FS_ID:40702 DS_ID:806 EP_NO: N/A Repair Type: Non-Urgent Crossing Status: Found UCIP Comments: No pipe found during site visit only air valve and power meter. Dense vegetation along waterward slope recommend clearing vegetation from slope to conduct proper pipe inspection. If crossing is no longer in use owner will need to coordinate with DWR inspector and CVFPB to remove according to Title 23 requirements. FIELD_STRUCT_DESC: *REMOVED* 20-inch steel drainage pipe through the levee 5-feet below the crown. Siphon breaker in steel riser on waterside (WS) shoulder and a flap gate on the WS toe. (20-inch pipe authorized under Permit No. 3799, 1961 - Libbey-Owens-Ford Glass Company; 24-inch pipe removed under Permit No. 15318, 1989 - Libby-Owens-Ford Glass Co. & Reclamation District 17 [RD0017], 20-inch pipe installed) [Additional Reference(s): DWR Levee Logs, 1981, 2003, 20-inch. USACE San Joaquin O&M Manual Unit No. 2, May 1963, (HLM 12.16), 20-inch pipe] FS Date: 2/4/2010

Overview of levee crown at crossing.

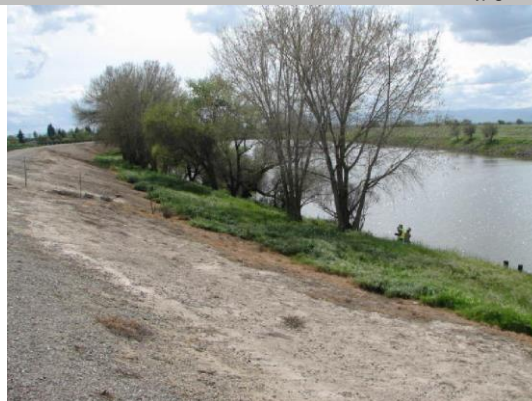
Photo 2 of 3 : UCIP_FA_2018_40702_72480.jpg

View of waterward side.

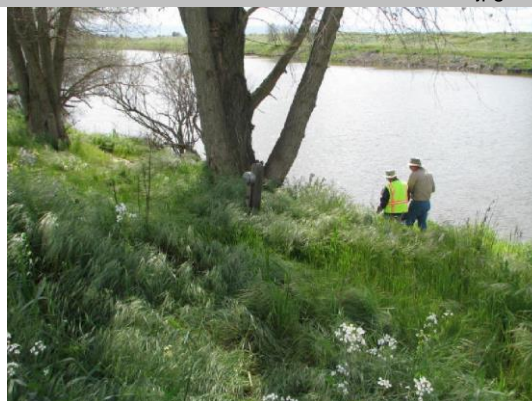
Photo 3 of 3 : UCIP_FA_2018_40702_72483.jpg

Dense vegetation along waterward slope--abandoned electrical box is visible through dense vegetation.

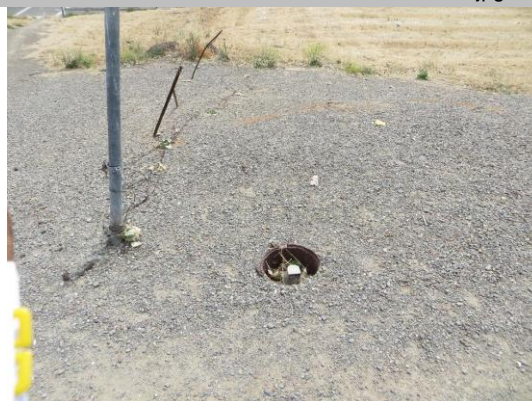
Photo 1 of 3 : UCIP_FA_2018_45464_74125.jpg

Comment Code					
Inspector Comment					
FS_ID:45464 DS_ID:56 EP_NO: 15318 Repair Type: Non-Urgent Crossing Status: Indicator Found UCIP Comments: Crossings appears to be abandoned. Need to contact owner to determine status of crossing. If abandoned, it should be done so properly. FIELD_STRUCT_DESC: 20-inch steel drainage pipe through levee, 3.4-feet below levee crown. Air vent in 12-inch steel riser found on the landside (LS) shoulder. Electric service riser on waterside (WS) berm has been removed. (20-inch pipe authorized under Permit No. 15318, 1989 - Libby-Owens-Ford Glass Co. & Reclamation District 17 [RD0017], 24-inch pipe removed) [Additional Reference(s): DWR Levee Logs, 1981 and 2003] FS Date: 5/21/2015

Vent in steel riser on LS shoulder.

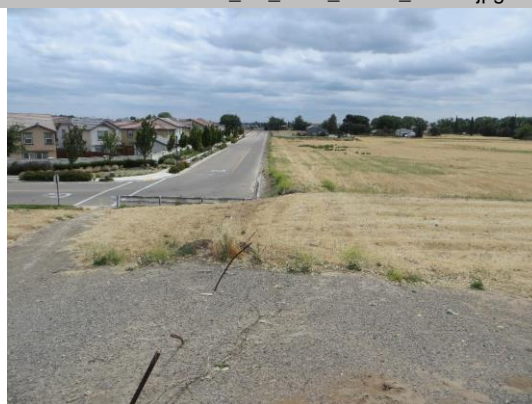
Photo 2 of 3 : UCIP_FA_2018_45464_74124.jpg

View of LS at crossing.

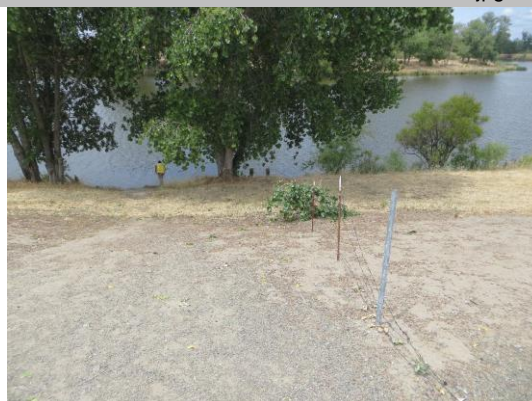
Photo 3 of 3 : UCIP_FA_2018_45464_74123.jpg

View of WS at crossing.

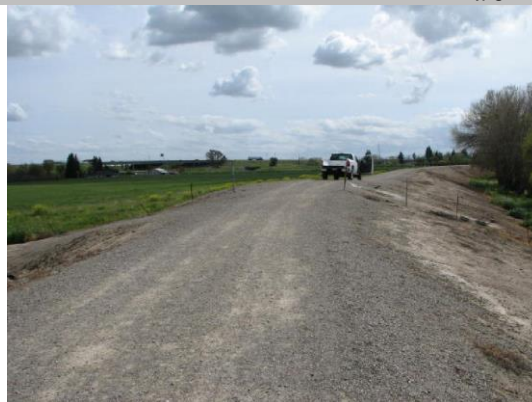
Photo 1 of 3 : UCIP_FA_2018_40703_72487.jpg

Comment Code					
Inspector Comment					
FS_ID:40703					
DS_ID:799					
EP_NO: N/A					
Repair Type: Non-Urgent					
Crossing Status: Found					
UCIP Comments: Need to contact owner to determine status of crossing and obtain additional information about crossing (permit and install date).					
FIELD_STRUCT_DESC: 48-inch steel drainage pipe through the levee, 2.5-feet below the crown. Siphon breaker on landside (LS) shoulder. Concrete "U" shaped headwall on waterside (WS) toe with flap gate. 8-4 inch steel coated scheduled 40 pipes located on WS shoulder about 6 inch cover. (48-inch pipe and 12-inch pipe authorized under Permit No. 15845, 1993 - City of Lathrop and Kearny Ventures)					
FS Date: 2/4/2010

Overview of levee crown at crossings.

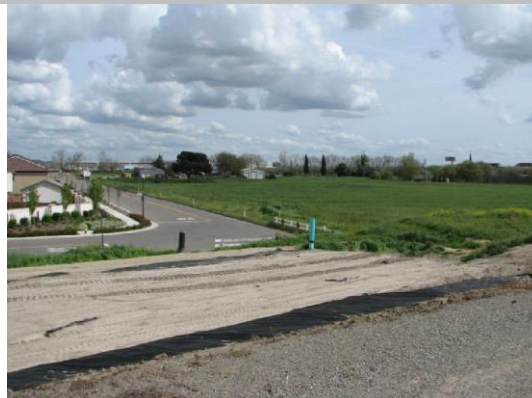
Photo 2 of 3 : UCIP_FA_2018_40703_72485.jpg

View of landward side, photo 1 of 2.

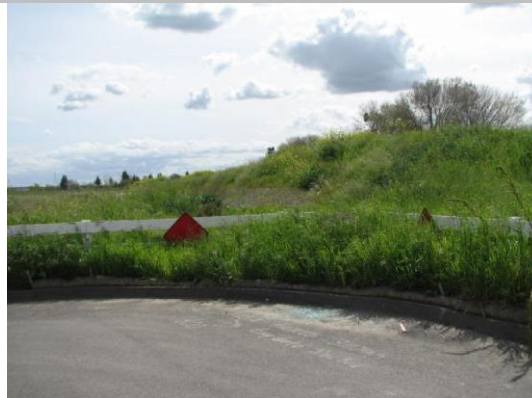
Photo 3 of 3 : UCIP_FA_2018_40703_72486.jpg

View of landward side, photo 2 of 2.

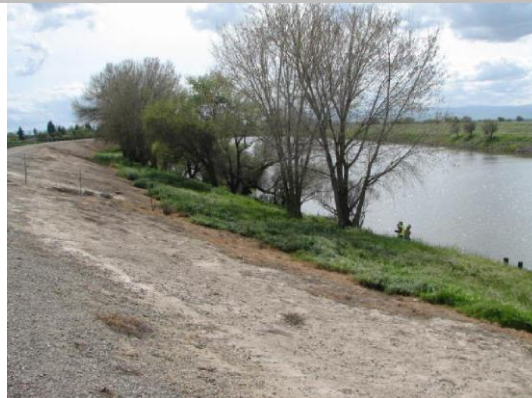
Photo 2 of 3 : UCIP_FA_2018_45993_72495.jpg

View of waterward side.

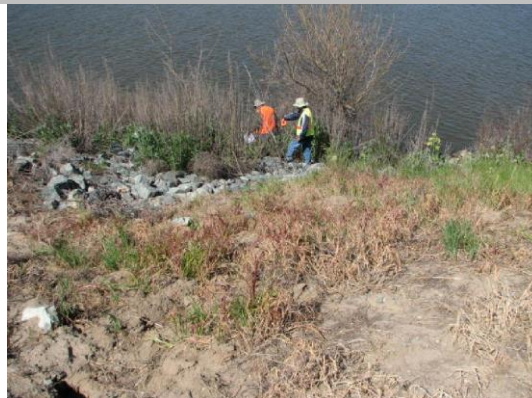
Photo 2 of 3 : UCIP_FA_2018_40706_72511.jpg

Item	DWR UCIP Field Study			37.789976 °	37.789976 °	
				-121.306853 °	-121.306853 °	
DWR ID	807					
Comment Code						
Inspector Comment						
FS_ID:40706						
DS_ID:807						
EP_NO: N/A						
Repair Type: Non-Urgent						
Crossing Status: Found						
UCIP Comments: Pipe disconnected on waterward side. Need to contact owner to determine status of crossing. If crossing is no longer in use owner will need to coordinate with DWR inspector and CVFPB to remove according to Title 23 requirements.						
FIELD_STRUCT_DESC: 8-inch irrigation pipe of unknown material through levee, 3.2-feet below the crown. Pump on waterside (WS) toe and a siphon breaker on the landside (LS) shoulder. (6-inch pipe authorized under Permit No. 15049, 1989 - T. and I. Queirolo, existing 6-inch pipe removed) [Additional Reference(s): DWR Levee Logs, 1981 and 2003]						
FS Date: 2/4/2010

View of waterward toe--rip rap along pipe alignment.

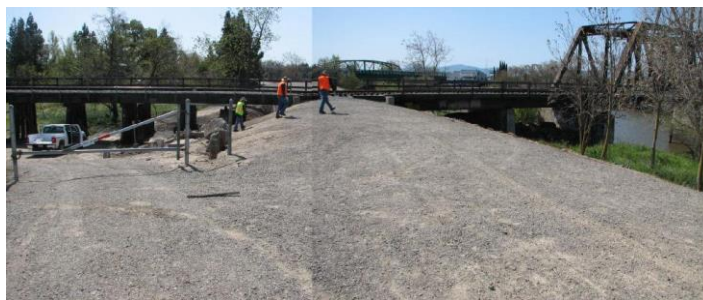
Photo 1 of 3 : UCIP_FA_2018_40707_72515.jpg

LM Start	12.55	Rating **	M	Issue No.	143
LM End	12.55	Issue Type +	En	Location *	
Category	Supplemental			GPS Latitude/Longitude	
				Start	End
Item	DWR UCIP Field Study			37.787929 °	37.787929 °
				-121.307173 °	-121.307173 °
DWR ID	60				
Comment Code					
Inspector Comment					
FS_ID:40707 DS_ID:60 EP_NO: 14326 Repair Type: Non-Urgent Crossing Status: Indicator Found UCIP Comments: Wires exposed near levee crown unable to determine if these wires are part of the crossing. Need to contact owner to determine status of crossing. FIELD_STRUCT_DESC: 4-inch galvanized iron communication cable through levee. Invert of conduit is 3.0 feet below levee crown. (4-inch fiber optic cable authorized under Permit No. 14326, 1986 - GTE Sprint Communications Corp.) [Additional Reference(s): DWR Levee Logs, 1981 and 2003] FS Date: 2/4/2010

Overview of levee crown at crossing.

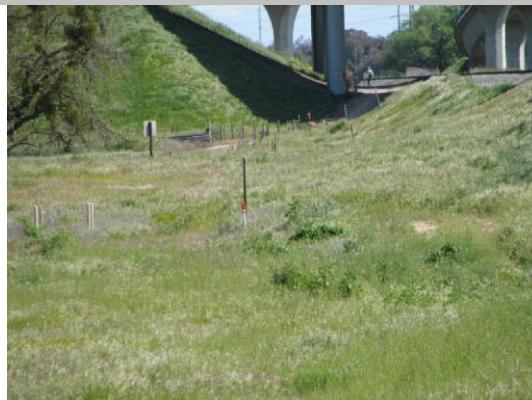
Photo 2 of 3 : UCIP_FA_2018_40707_72514.jpg

Crossing alignment along landward side.

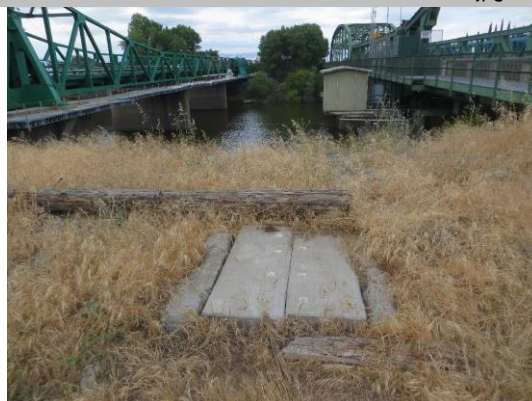
Photo 2 of 3 : UCIP_FA_2018_45466_74131.jpg

Item	DWR UCIP Field Study			37.786343 °	37.786343 °	
				-121.306157 °	-121.306157 °	
DWR ID	808					
Comment Code						
Inspector Comment						
FS_ID:45466 DS_ID:808 EP_NO: 2366 Repair Type: Non-Urgent Crossing Status: Found UCIP Comments: Pipe exposed on WS slope where soil has been removed from around pipe. There does not appear to be any damage or repair at excavation. Pipe should be buried. FIELD_STRUCT_DESC: 22-inch steel drainage pipe through the levee, 10-feet below levee crown. 54-inch square, concrete manhole at the centerline of the levee between Manthey Road and the HWY 120 on ramp to I-5. (22-inch pipe authorized under Permit No. 2366, 1956 - State of California Department of Public Works Division of Highways District X) [Additional Reference(s): DWR Levee Logs, 1981, 2003, 22-inch listed. USACE San Joaquin O&M Manual Unit No. 2, May 1963, (HLM 12.74), 22-inch pipe] FS Date: 5/21/2015

Concrete manhole on WS shoulder.

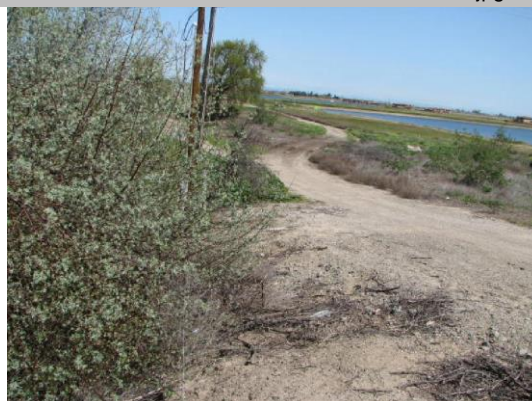
Photo 1 of 3 : UCIP_FA_2018_40712_72529.jpg

LM Start	13.26	Rating **	M	Issue No.	145
LM End	13.26	Issue Type +	En	Location *	
Category	Supplemental			GPS Latitude/Longitude	
				Start	End
Item	DWR UCIP Field Study			37.779653 °	37.779653 °
				-121.300064 °	-121.300064 °
DWR ID	65				
Comment Code					
Inspector Comment					
FS_ID:40712 DS_ID:65 EP_NO: 14450 Repair Type: Non-Urgent Crossing Status: Found UCIP Comments: Need to contact owner to determine status of crossing. FIELD_STRUCT_DESC: [Oakwood Lake Discharge Lines] 1 of 2. 18-inch steel drainage discharge pipe through levee at unknown depth below the levee crown. (two 18-inch pipes authorized under Permit No. 14450-1985 - R. H. Brown, remove existing 18-inch pipe) [Additional Reference(s): DWR Levee Logs, 1981 and 2003] FS Date: 2/4/2010

View of landward side.

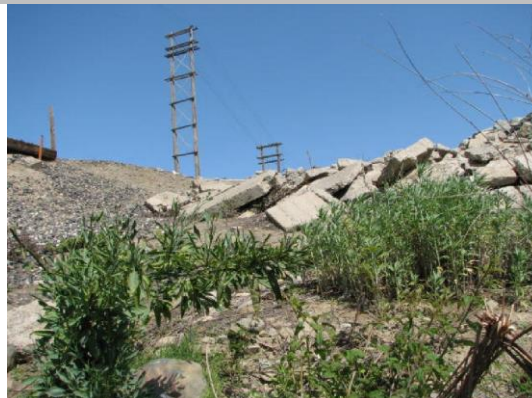
Photo 3 of 3 : UCIP_FA_2018_40712_72530.jpg

View of waterward slope.

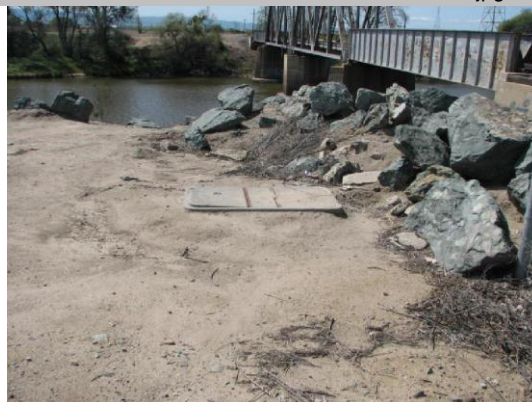
Photo 1 of 3 : UCIP_FA_2018_40713_72534.jpg

LM Start	13.26	Rating **	M	Issue No.	146	
LM End	13.26	Issue Type +	En	Location *		
Category	Supplemental			GPS Latitude/Longitude		
				Start		End
Item	DWR UCIP Field Study			37.779643 °		37.779643 °
				-121.300057 °		-121.300057 °
DWR ID	287					
Comment Code						
Inspector Comment						
FS_ID:40713 DS_ID:287 EP_NO: 14450 Repair Type: Non-Urgent Crossing Status: Found UCIP Comments: Need to contact owner to determine status of crossing. FIELD_STRUCT_DESC: [Oakwood Lake Discharge Lines] 2 of 2. 18-inch steel drainage discharge pipe through levee at unknown depth below the levee crown. (two 18-inch pipes authorized under Permit No. 14450-1985 - R. H. Brown, remove existing 18-inch pipe) [Additional Reference(s): DWR Levee Logs, 1981 and 2003] FS Date: 2/4/2010

Precast concrete box located on levee shoulder.

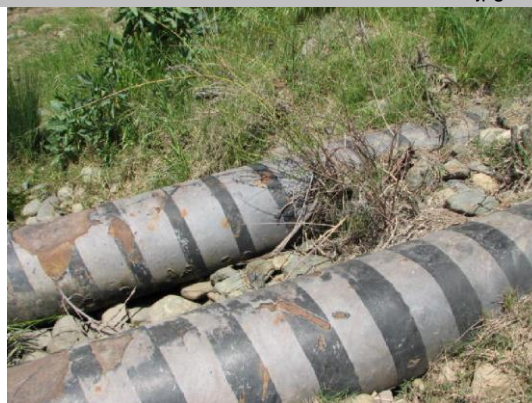
Photo 2 of 3 : UCIP_FA_2018_40713_72533.jpg

Pipes visible on waterward side.

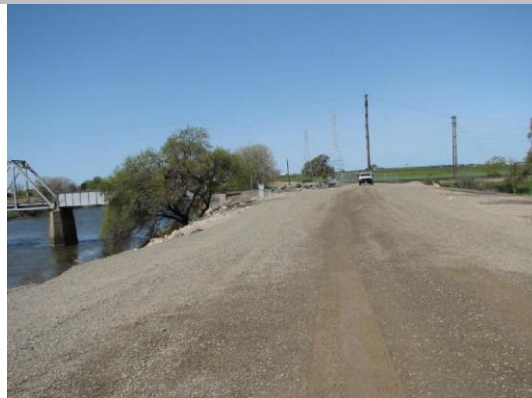
Photo 1 of 3 : UCIP_FA_2018_40714_72545.jpg

Comment Code					
Inspector Comment					
FS_ID:40714 DS_ID:66 EP_NO: 14467 Repair Type: Non-Urgent Crossing Status: Found UCIP Comments: Records show this crossing was suppose to be abandoned however, the drain pipe was operable during site visit. Need to contact owner to clarify if crossing that was abandoned was removed and replaced with current crossing. FIELD_STRUCT_DESC: 36-inch concrete discharge gravity municipal water discharge through levee approximately 23 feet below crown. The reinforced concrete outfall structure with sluice gate will be constructed within the pipeline at the waterside (WS) levee shoulder. (36-inch pipe authorized under Permit No. 14467, 1986 - City of Manteca) [Additional Reference(s): DWR Levee Logs, 1981 and 2003] FS Date: 2/4/2010

Overview of levee crown at crossing.

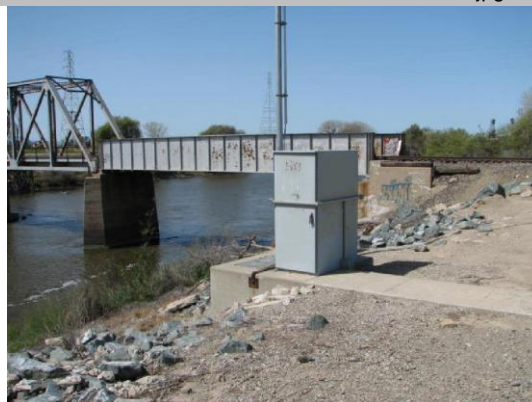
Photo 2 of 3 : UCIP_FA_2018_40714_72539.jpg

Control box and distribution box located on waterward shoulder.

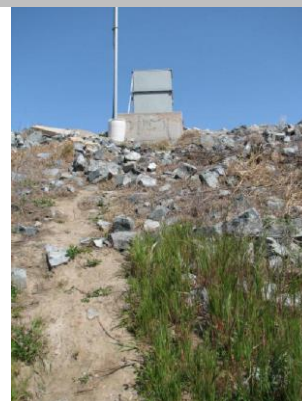
Photo 3 of 3 : UCIP_FA_2018_40714_72542.jpg

View of waterward side.

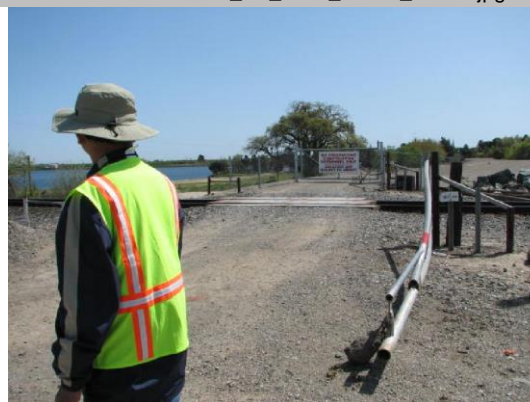
Photo 1 of 2 : UCIP_FA_2018_45995_72526.jpg

LM Start	13.28	Rating **	M	Issue No.	148	
LM End	13.28	Issue Type +	En	Location *		
Category	Supplemental			GPS Latitude/Longitude		
				Start	End	
Item	DWR UCIP Field Study			37.779470 °	37.779470 °	
				-121.299954 °	-121.299954 °	
DWR ID	67					
Comment Code						
Inspector Comment						
FS_ID:45995						
DS_ID:67						
EP_NO: N/A						
Repair Type: Non-Urgent						
Crossing Status: Indicator Found						
UCIP Comments: Markers visible on landward side only. Recommend contacting owner to confirm alignment and crossing.						
FIELD_STRUCT_DESC: Submarine power cable through the levee and across the channel. [Additional Reference(s): DWR Levee Logs, 1981 and 2003]						
FS Date: 2/4/2010

View of levee crown at crossing.

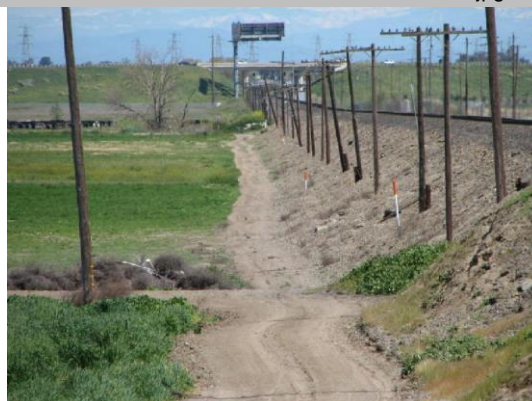
Photo 2 of 2 : UCIP_FA_2018_45995_72525.jpg

Markers visible along landward side.

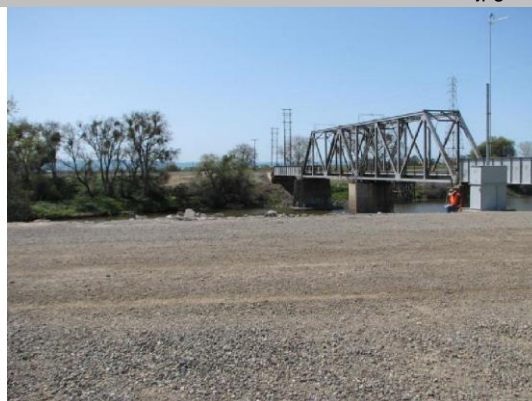
Photo 1 of 3 : UCIP_FA_2018_40715_72548.jpg

Comment Code					
Inspector Comment					
FS_ID:40715 DS_ID:809 EP_NO: N/A Repair Type: Non-Urgent Crossing Status: Found UCIP Comments: No information was obtained from desk study. This crossing was found during field visit. Need to contact owner to obtain additional details about crossing (installation date and permit) and status. FIELD_STRUCT_DESC: *ABANDONED* [Reclamation District No. 17 Drainage Plant] 18-inch drainage pipe of unknown material through the levee, 5.8 feet below the crown. Gate valve and siphon breaker on the waterside (WS) slope. Flap gate on the WS end. One CM cutoff wall. Pump on the landside (LS). (18-inch pipe Installed by USACE in 1961 -- no permit found; existing 18-inch pipe removed under Permit No. 14450, 1988 - R. H. Brown, two 18-inch pipes installed) [Additional Reference(s): DWR Levee Logs, 1981, 2003. USACE San Joaquin O&M Manual Unit No. 2, May 1963, (HLM 13.36)] FS Date: 2/4/2010

View of levee crown at crossing.

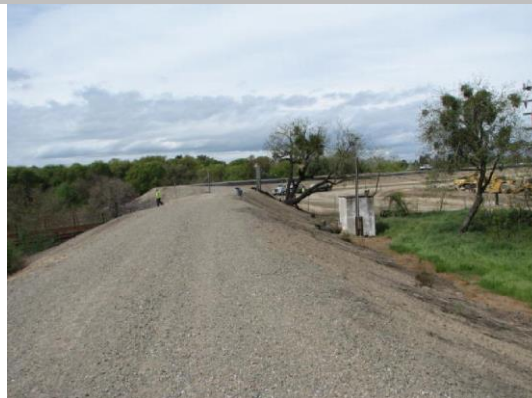
Photo 1 of 3 : UCIP_FA_2018_40716_72557.jpg

Comment Code						
Inspector Comment						
FS_ID:40716 DS_ID:69 EP_NO: 15165 Repair Type: Non-Urgent Crossing Status: Found UCIP Comments: Pump was working during the survey. Levee toe erosion at waterward side. Recommend contacting owner to determine status and to evaluate erosion at waterward toe. FIELD_STRUCT_DESC: 20-inch steel irrigation pipe through the levee, 1.7-feet below the crown. Pump on pile structure in the stream. Wooden walkway to the pump. concrete distribution box at the toe of the landside (LS) slope. (20-inch pipe authorized under Permit No. 15165, 1989 - Baird Lands, Inc., existing 18-inch pipe removed) [Additional Reference(s): DWR Levee Logs, 1981 and 2003] FS Date: 2/4/2010

Overview of levee crown at crossing.

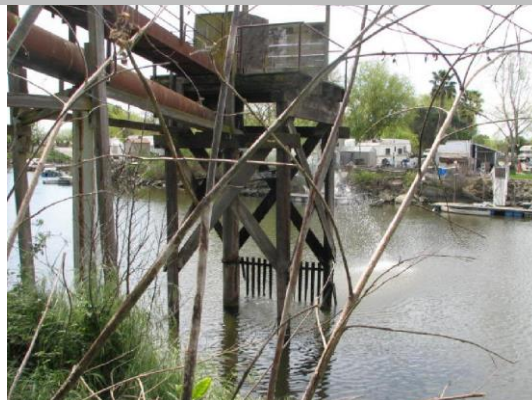
Photo 2 of 3 : UCIP_FA_2018_40716_72556.jpg

Pipe operable during survey.
